THREE SISTERS CREEK DEVELOPMENT

# Three Sisters Creek Hazard Assessment Update

Final Rev. 2  
October 9, 2020

BGC Project No.:  
**1531003**

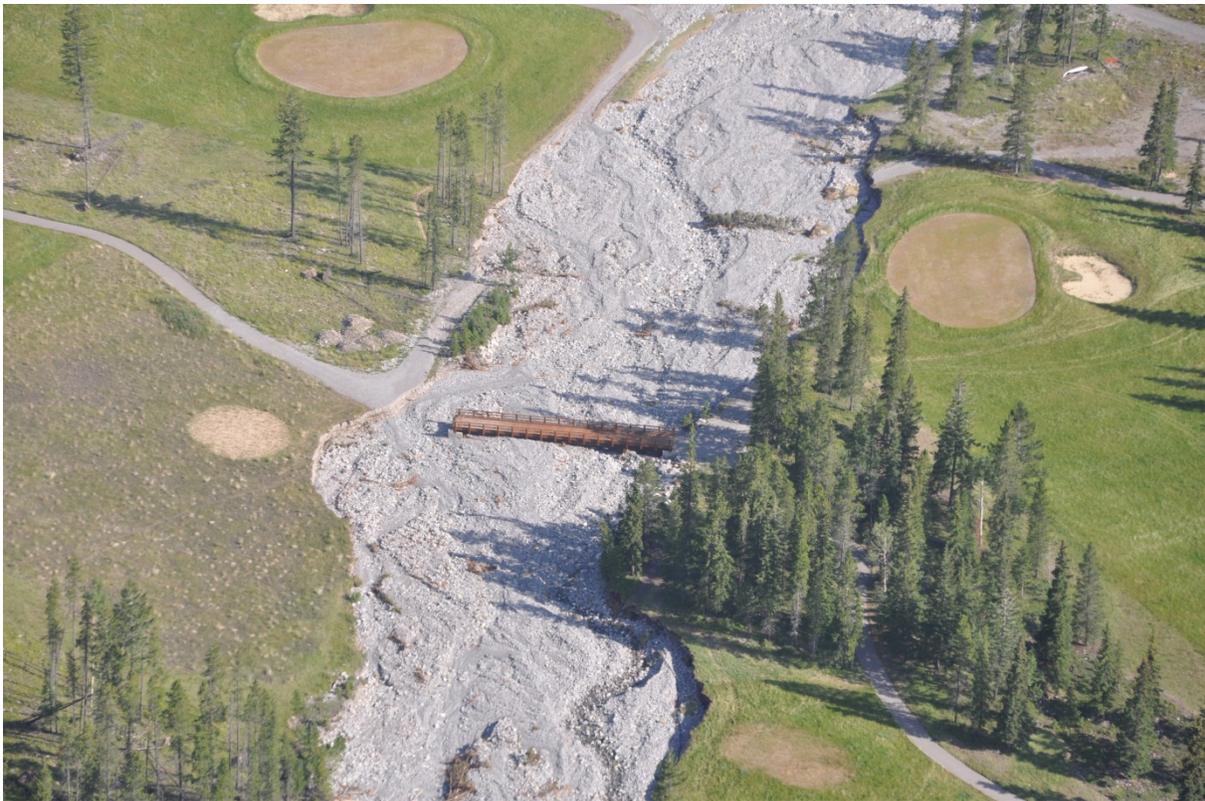
**Figure 3-5. Aerial view of Three Sisters Creek looking downstream. The Upper Bridge was outflanked on both banks during the June 2013 debris flood. BGC photograph of July 23, 2013.**

In addition to potential damage from the inundation of fans with water and debris, debris floods damage infrastructure through bank erosion due to the high shear stresses exerted on stream channel beds and banks. In the Bow Valley, the steep creek banks on fans consist predominantly of unconsolidated, loose, and non-cohesive sandy gravels. Removal of trees along Three Sisters Creek during construction of the golf course has also limited the bank strength from vegetation along the channel, which is an important source of apparent cohesion in coarse-grained creeks. The combination of non-cohesive bank material with little root strength makes the banks of Three Sisters Creek particularly susceptible to bank erosion, as evidenced by the extensive erosion that occurred during the June 2013 debris flood (Figure 3-5).

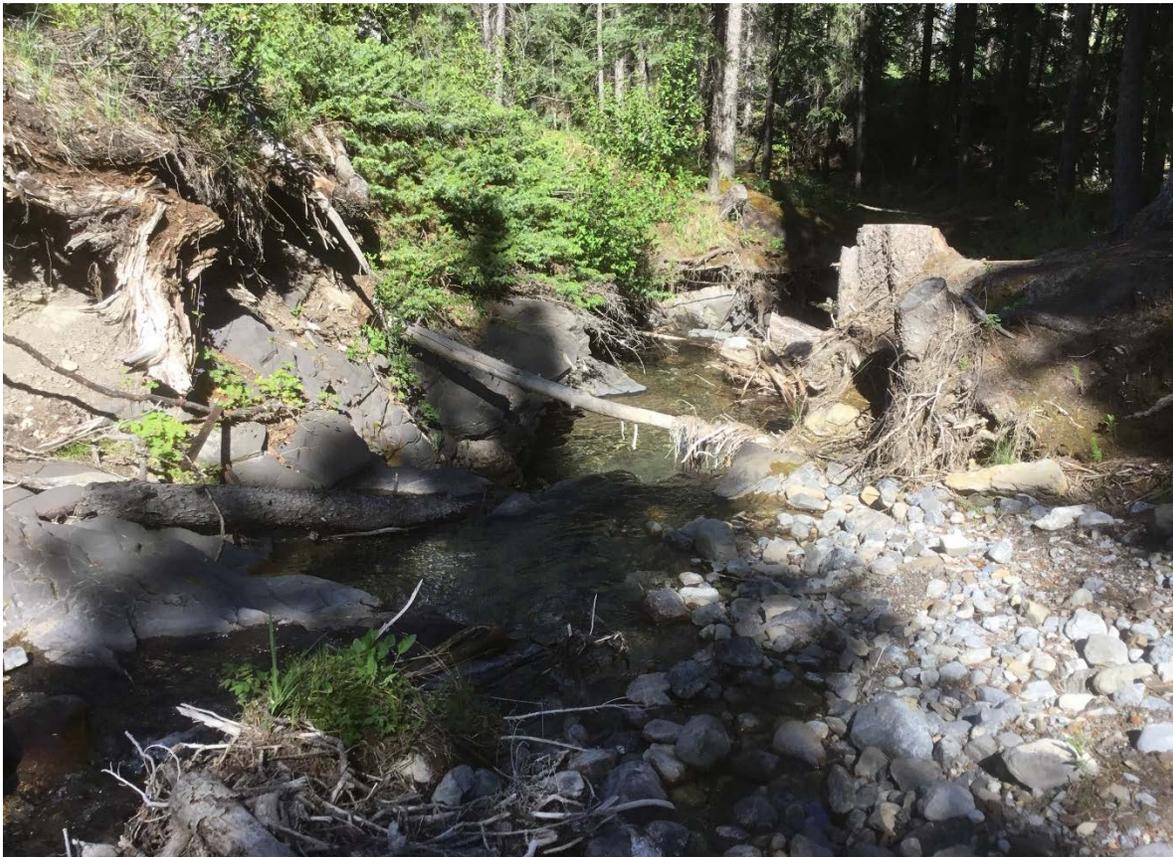
**Figure 3-6. Bedrock outcrop on the left side of the channel in the Lower Fan. BGC photograph of June 14, 2018.**

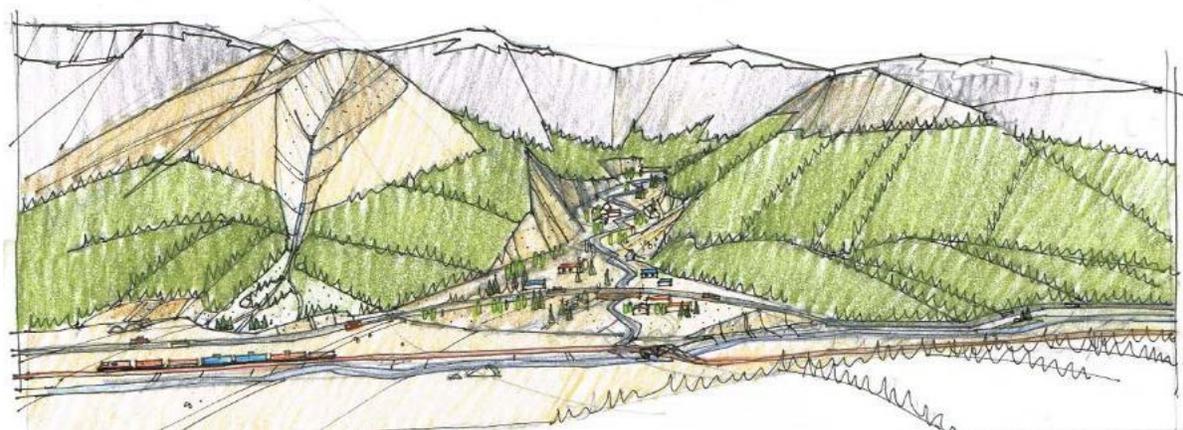
**Figure A-2. Typical steep and low-gradient fans feeding into a broader floodplain. On the left a small watershed prone to debris flows has created a steep fan that may also be subject to rock fall processes. On the right a larger watershed prone to debris flows has created a lower gradient fan. Development and infrastructure are shown to illustrate their interaction with steep creek geohazard events. Artwork: Derrill Shuttleworth.**

Figure A-2 schematically illustrates two fans side by side. The steeper one on the left is dominated by debris flows and perhaps rock fall near the fan apex, whereas the one on the right with the lower gradient is likely dominated by debris floods.

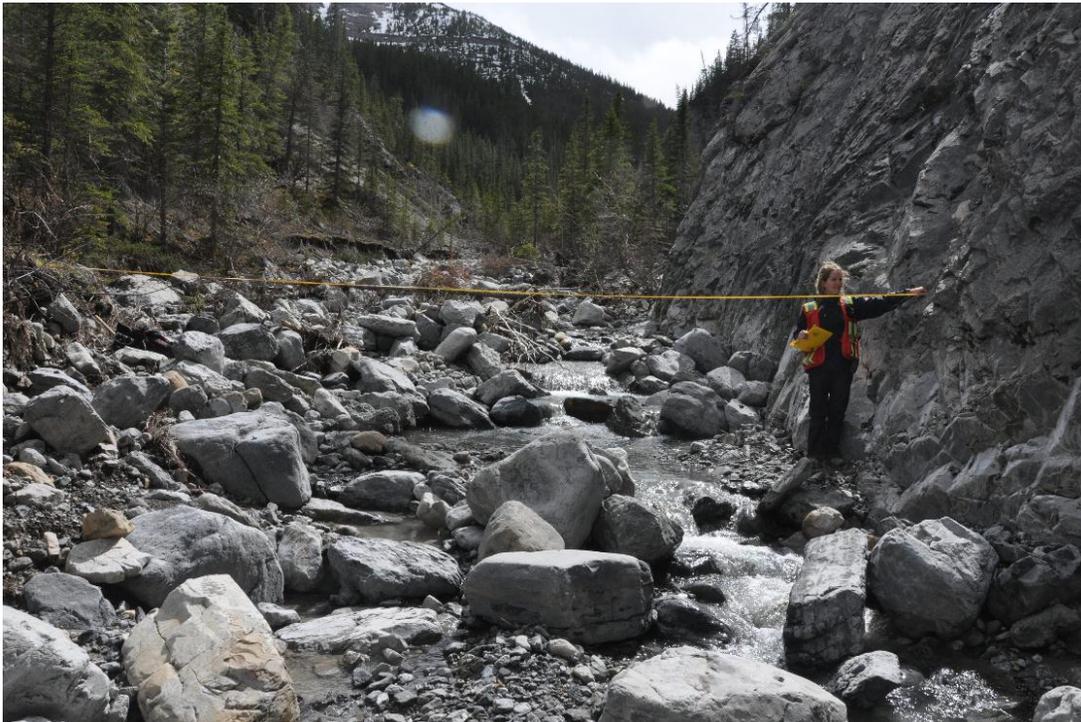
**Figure B-2. Upstream view of Three Sisters Creek high water mark at WP3. BGC photograph of May 29, 2014.**
