13 January 2021

THREE SISTERS MOUNTAIN VILLAGE

Undermining Information Session

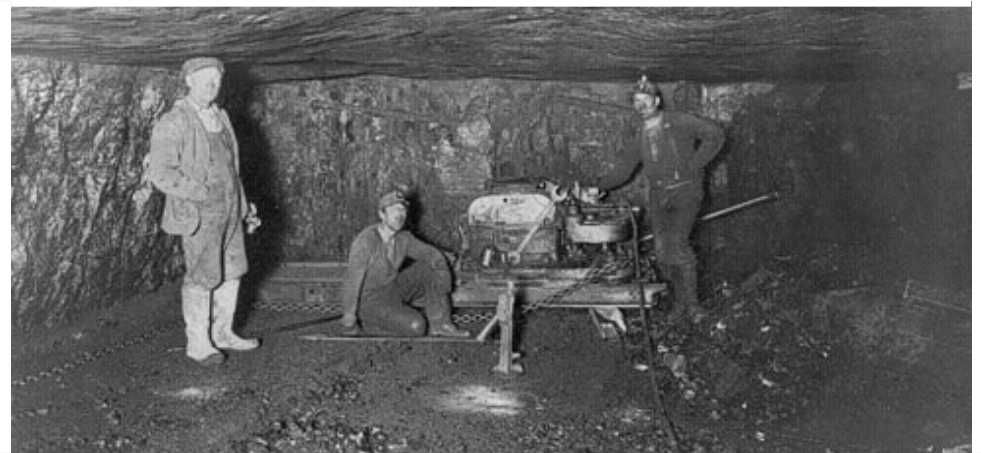
Mining Techniques

- Generally room and pillar, with pillar extraction following
- Drill and blast
- Initially air locomotives and rope haulages for 1.5 to 2 tonne cars
- Later continuous miners and cable reel shuttle cars, then slusher hoists
- Surface mines used for subvertical near-surface deposits

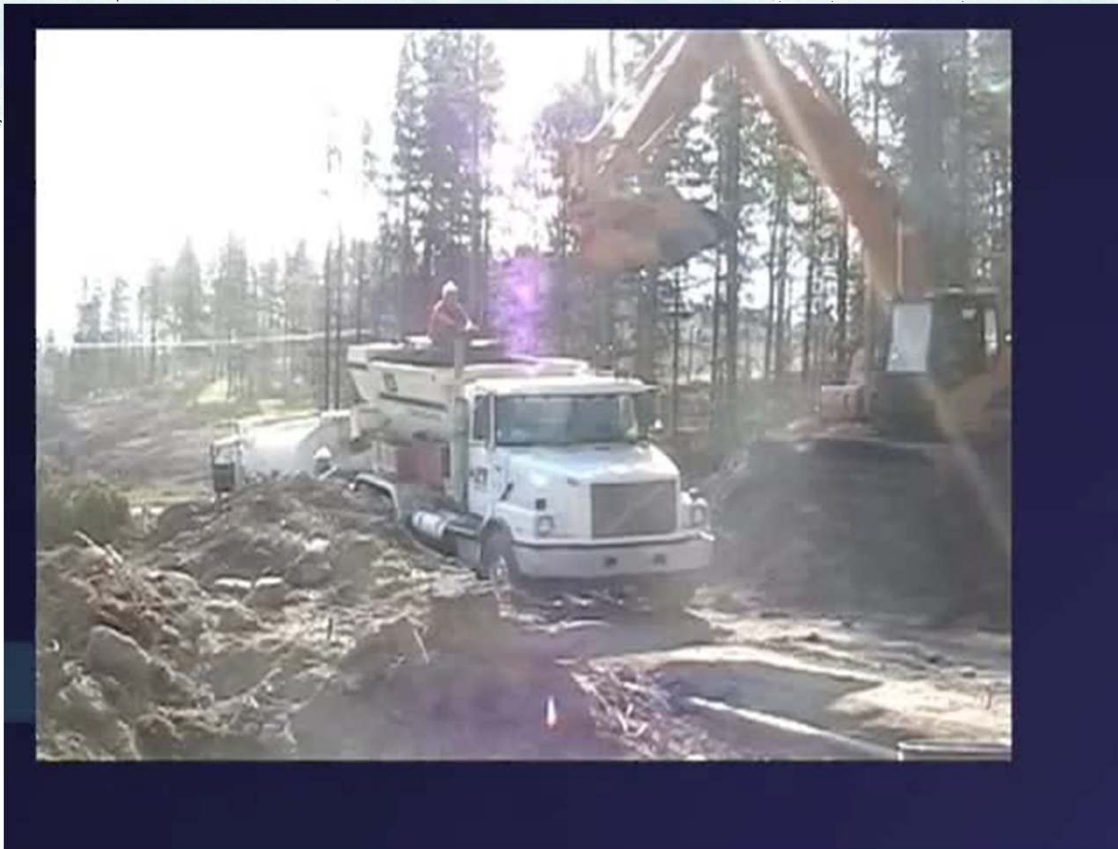
Mitigation Through Paste Operations

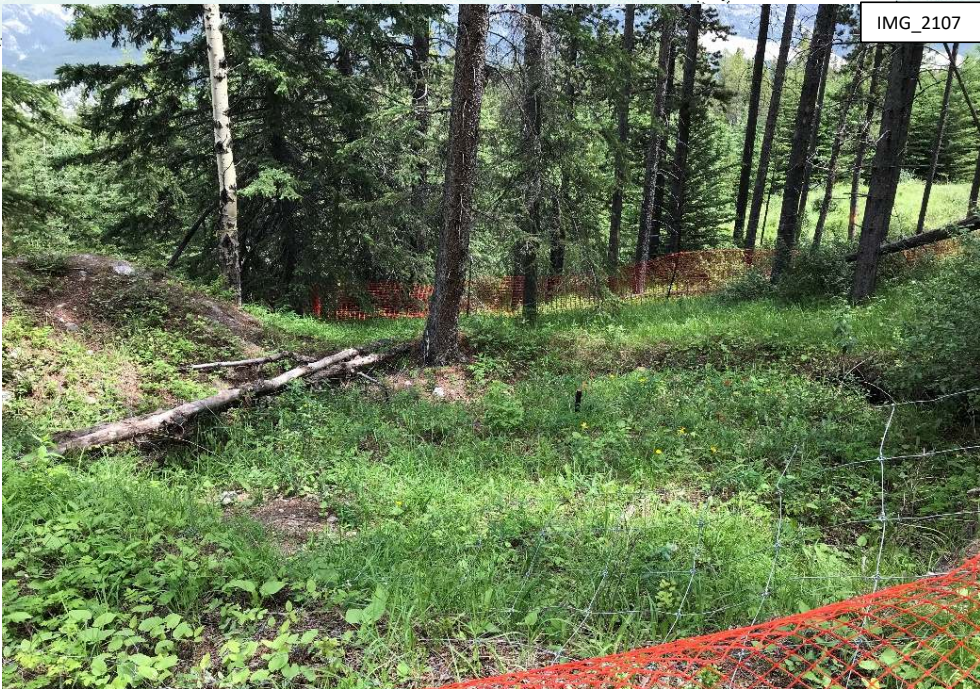
Photograph 1: Feature #74, June 2020

IMG_2107

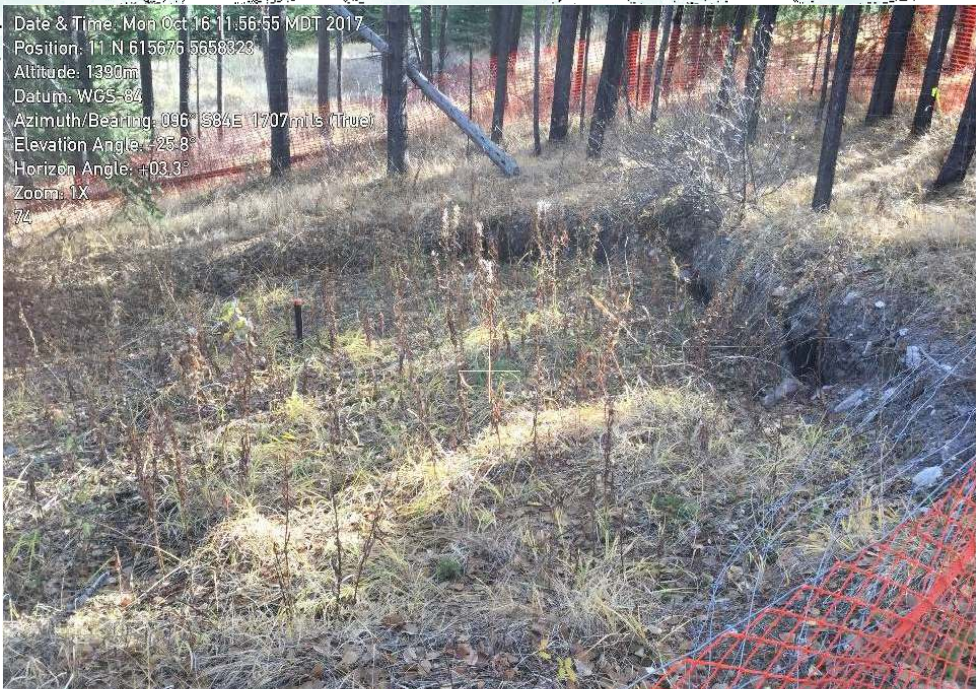
Photograph 1A: Feature #74, October 2017

Date & Time: Mon Oct 16 11:56:55 MDT 2017
Position: 11 N 615676 5658323
Altitude: 1390m
Datum: WGS-84
Azimuth/Bearing: 096° S86E 1707mils (True)
Elevation Angle: -25.3°
Horizon Angle: +03.3°
Zoom: 1X
74

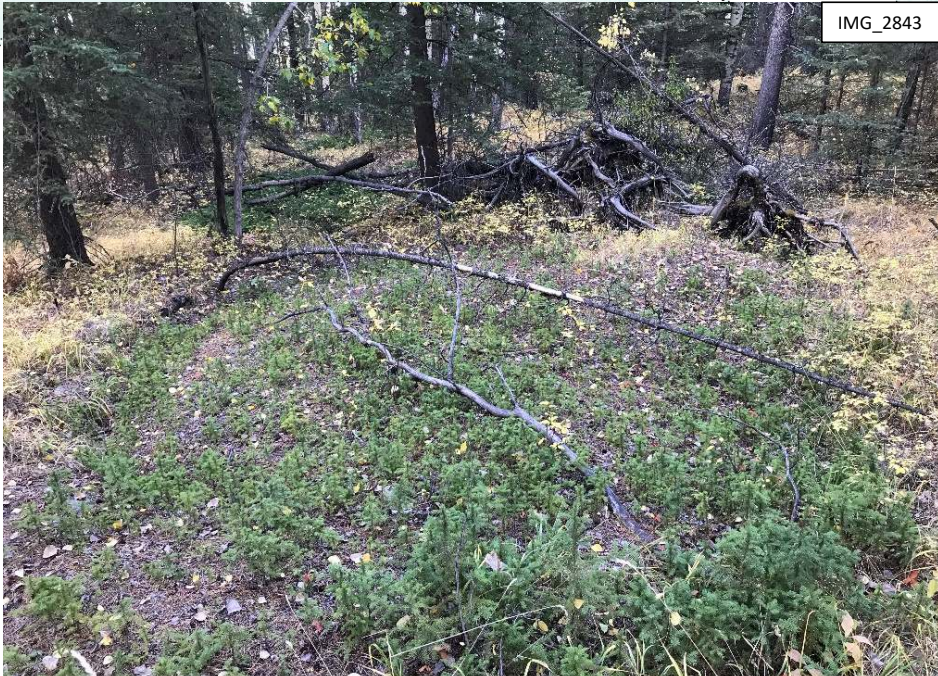
Shaft Location: #63

Photograph 38: Known shaft location with settlement at Waypoint 144, September 2020

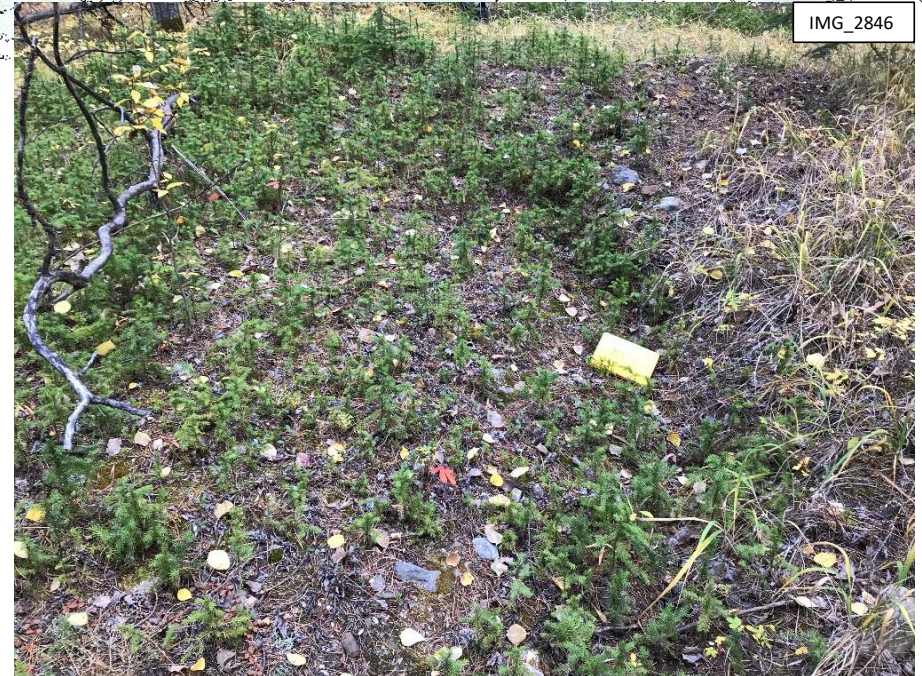
Photograph 40: Known shaft location with settlement at Waypoint 144, September 2020

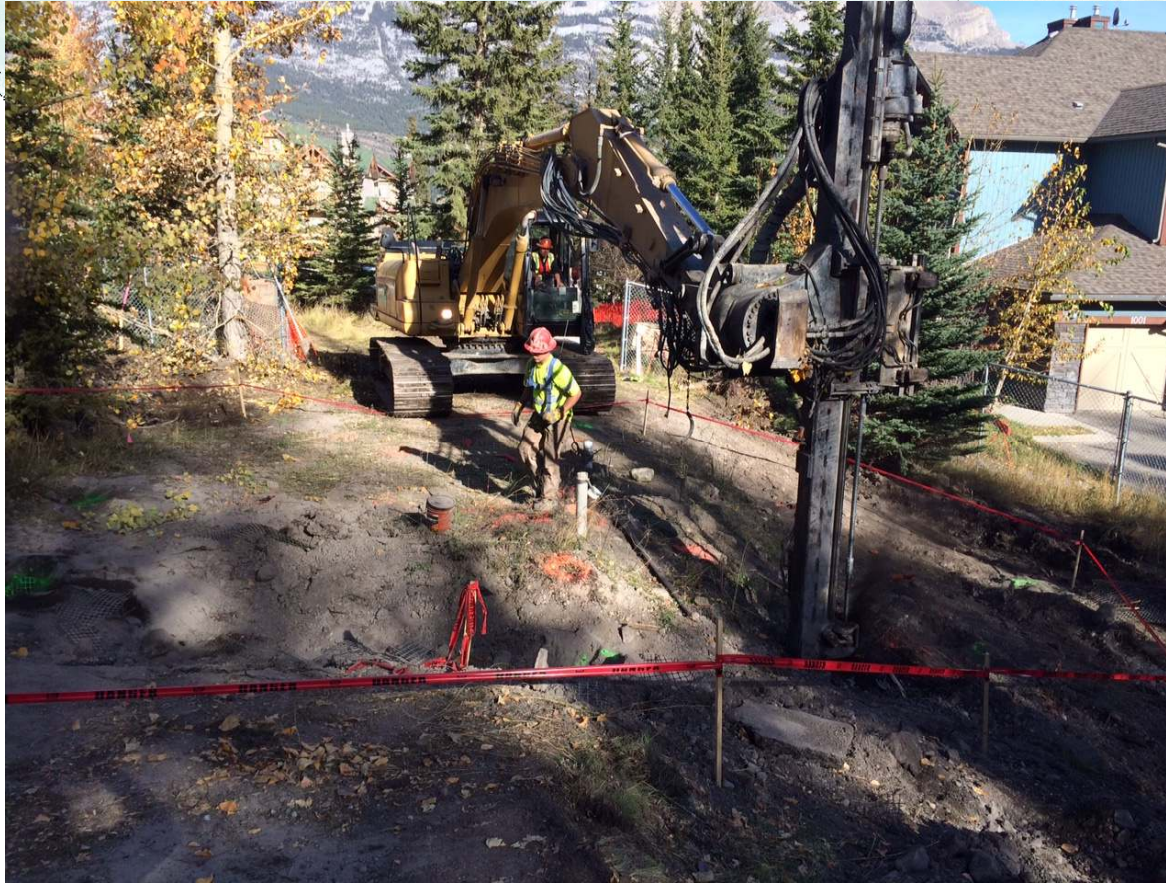
Dyrgas Sinkhole – B14 Airshaft (2010)

- B14 airfan shaft abandoned and backfilled by No. 4 mine operators prior to 1949, replaced with fan slope CP-4.
- Norwest attempted to find exact location of shaft in late 90's; not exactly located so broad “beanbag” public safety mitigation installed over general area of shaft.
- Golder undertook further work to find exact shaft location in 2003; found miners previous backfill extents around shaft; installed two layers of geosynthetics for future safe recreation use; set buildings back 15 m from area
- Leaking irrigation line suspected to be linked to settlement in May 2010; shaft was found to not be open but filled with wet, loose materials that settled
- Repaired in 2017 with three layers of geosynthetics similar to 2003 recommendations
